THE EFFECT OF TEST VARIABLES ON THE FRACTOGRAPHY OF
IN 718 OVERLOAD FCP SPECIMENS

Prepared by
Eui W. Lee
and
Stephen D. Antolovich

Submitted to
T. Cook
General Electric Co.

AN INVESTIGATION OF NON-ISOTHERMAL FATIGUE IN IN 718

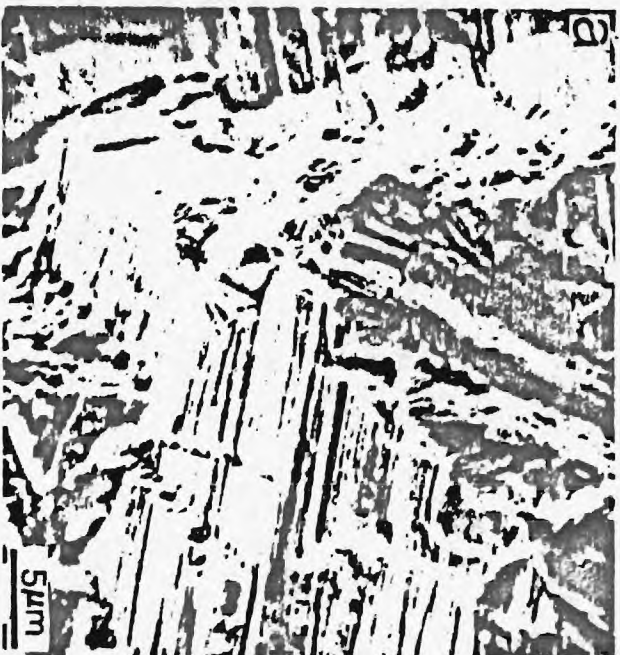
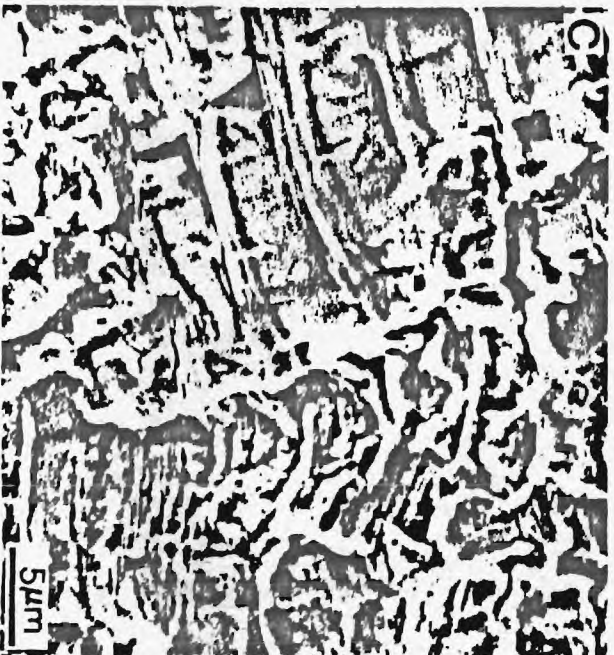
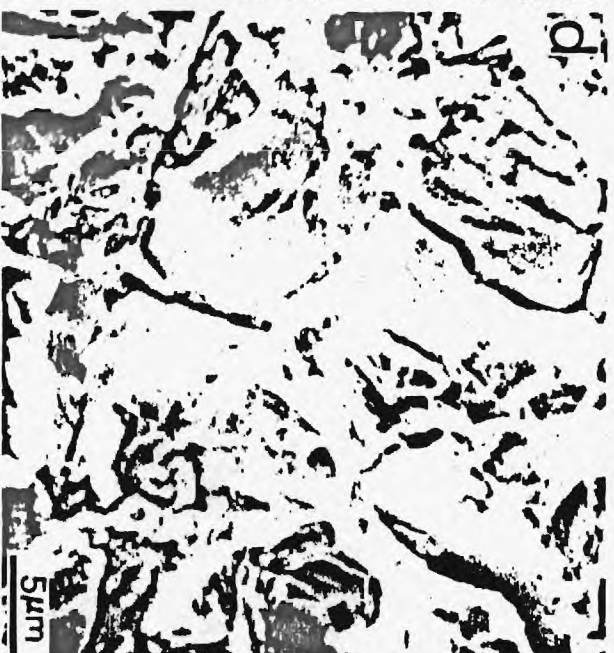
Figure 1-a. #4-81, 800°F, n=100, $\Delta K_c = 25.7$, 50% overload.
 1-b. #4-82, 1200°F, n=100, $\Delta K_c = 26.0$, 50% overload.
 1-c. #4-85, 800°F, n=100, $\Delta K_c = 27.4$, 100% overload.
 1-d. #4-84, 1200°F, n=100, $\Delta K_c = 26.5$, 100% overload.

For all the samples, fatigue striations were observed at $\Delta K \approx 25 \text{ Ksi in}^{\frac{1}{2}}$. The striations were more distinct at low temperature than at high temperature and were more evident when the number of constant amplitude cycles between overloads (n) was 10 rather than 100 (Figs. 1 and 2). This is due to the fact

that is a greater number of overload cycles when $n = 10$ compared to $n = 100$. The morphology of the fracture surface becomes increasingly noncrystallographic with increasing test temperature (Fig. 1a, 1b). For the specimens subjected to a longer hold time at maximum ΔK , cracks are increasingly associated with striations and secondary cracks are formed in the striations normal to the main fracture surface (Fig. 3).

The beneficial effects of overload usually found at room temperature seem to disappear at high temperature because the residual stresses induced by overload are apparently rapidly relieved at high temperature. One possible beneficial effect of overload at high temperature may be the increased fatigue crack closure since striations associated with oxide build-up and a rough fracture surface due to the overload may increase contact asperity. Effectively both oxide-induced closure and roughness-induced closure are operative at high temperature.

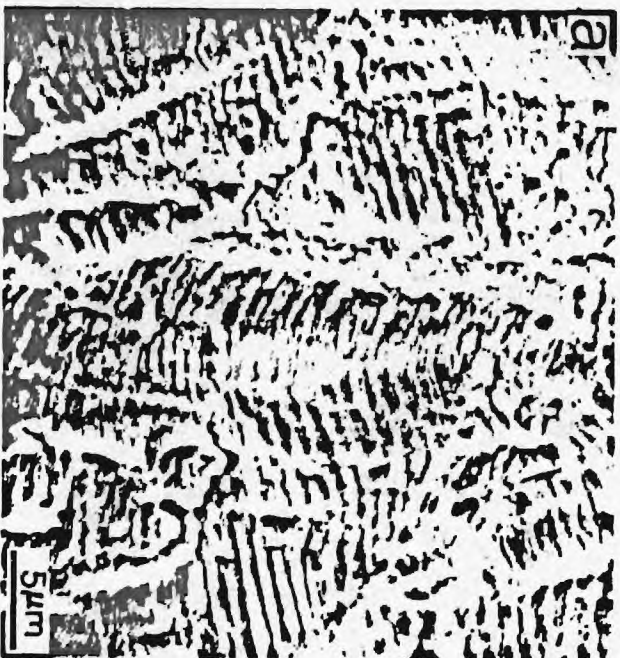
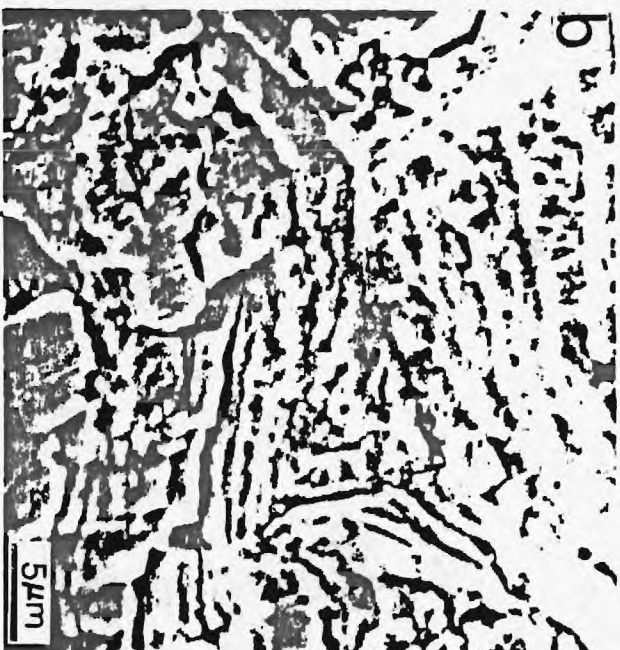
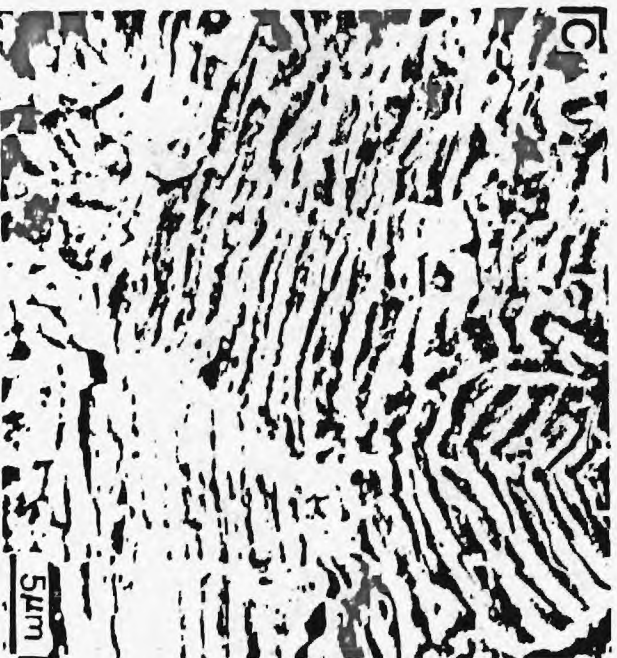
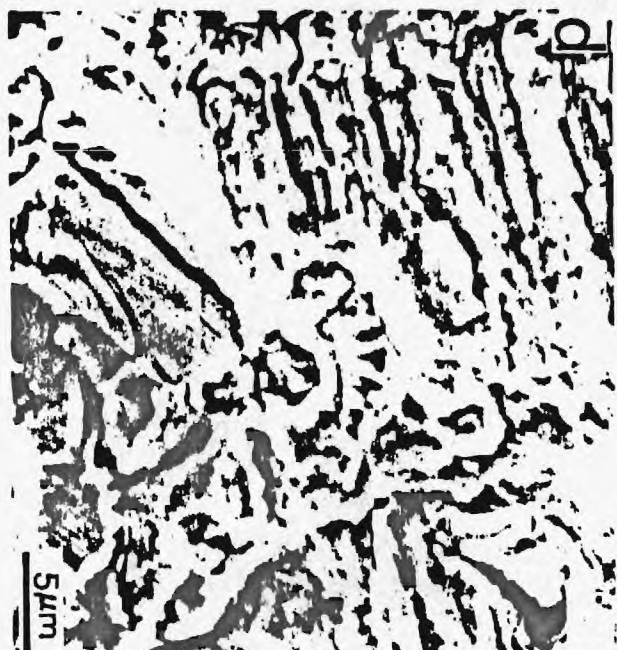
Figure 2-a. #4-96, 800°F, $n=10$, $\Delta K_c = 26.0$, 50% overload.
 2-b. #4-91, 1200°F, $n=10$, $\Delta K_c = 26.0$, 50% overload.
 2-c. #5-88, 800°F, $n=10$, $\Delta K_c = 26.5$, 100% overload.
 2-d. #4-97, 1200°F, $n=10$, $\Delta K_c = 27.1$, 100% overload.

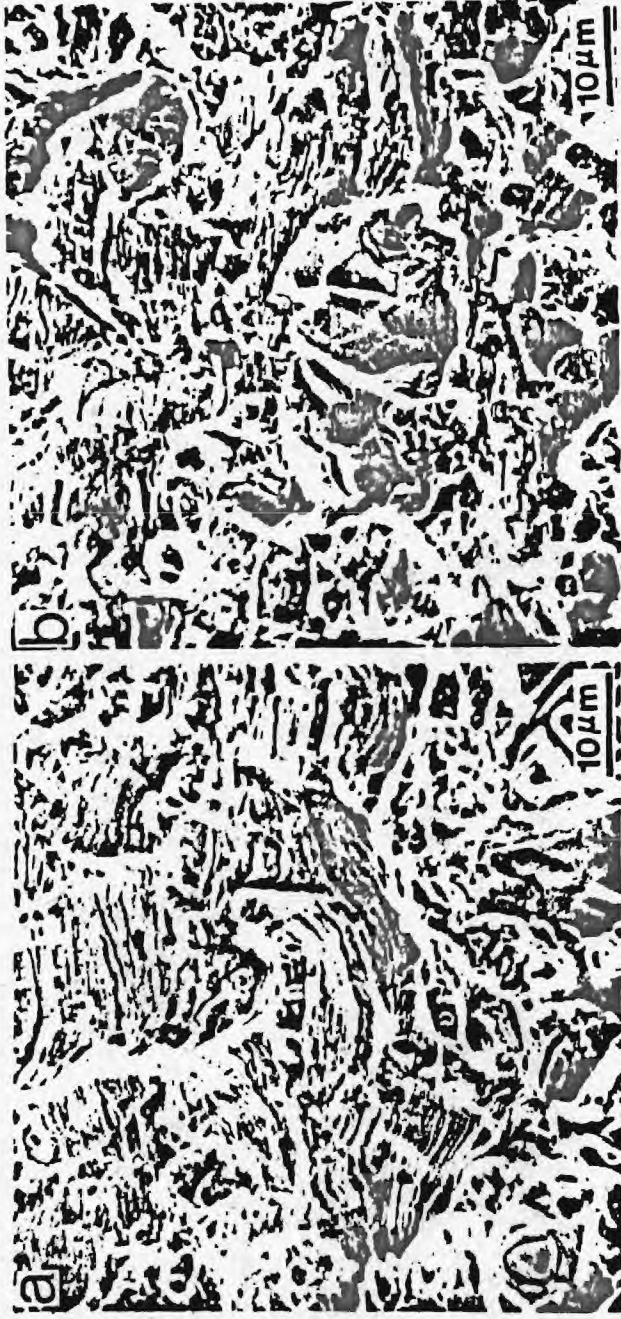
Figure 5-a. #4-96, 800°F, $n=10$, $\Delta K_b = 54.6$, 50% overload.
 5-b. #4-91, 1200°F, $n=10$, $\Delta K_b = 53.3$, 50% overload.
 5-c. #5-88, 800°F, $n=10$, $\Delta K_b = 35.0$, 100% overload.
 5-d. #4-97, 1200°F, $n=10$, $\Delta K_b = 31.3$, 100% overload.

1. The transition occurred at marginally higher values of ΔK_b , the lower the temperature for a given overload ratio. This effect is more significant for ΔK_{OL} . Typical transition fracture surface features are shown in Figs. 4 and 5.

3. The transition ΔK_b decreased with increasing overload ratio. This effect was more significant for $n = 10$ compared to $n = 100$. Figures 4a, 4c, 5a and 5c show features associated with this effect.

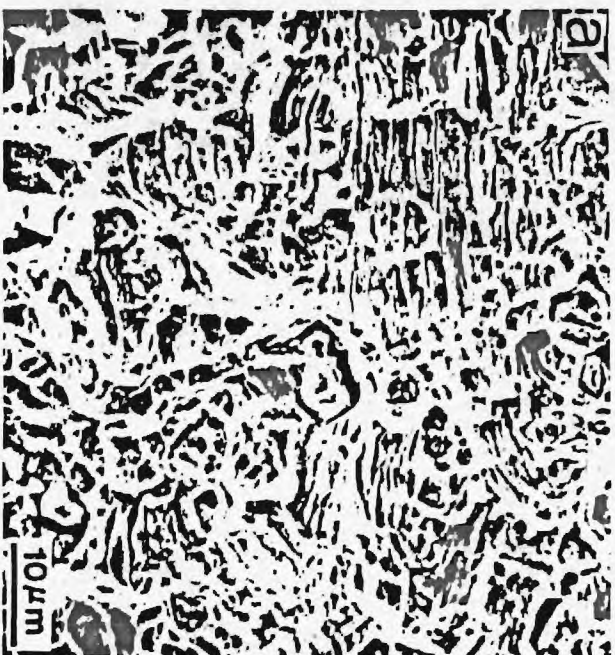
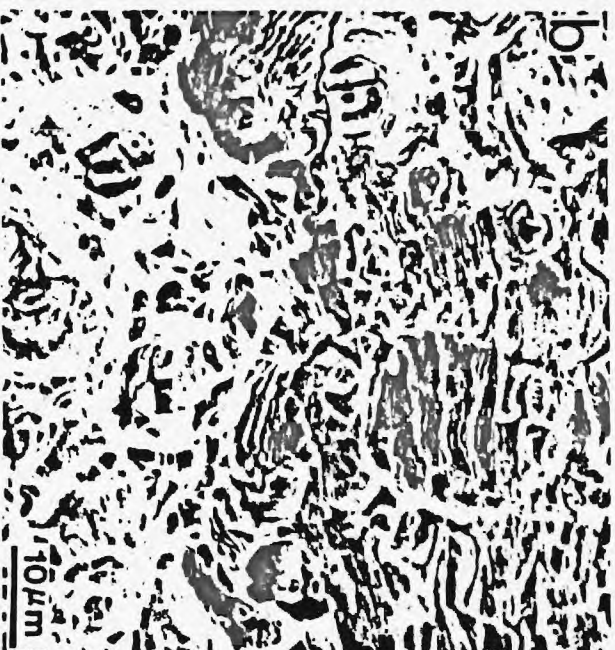
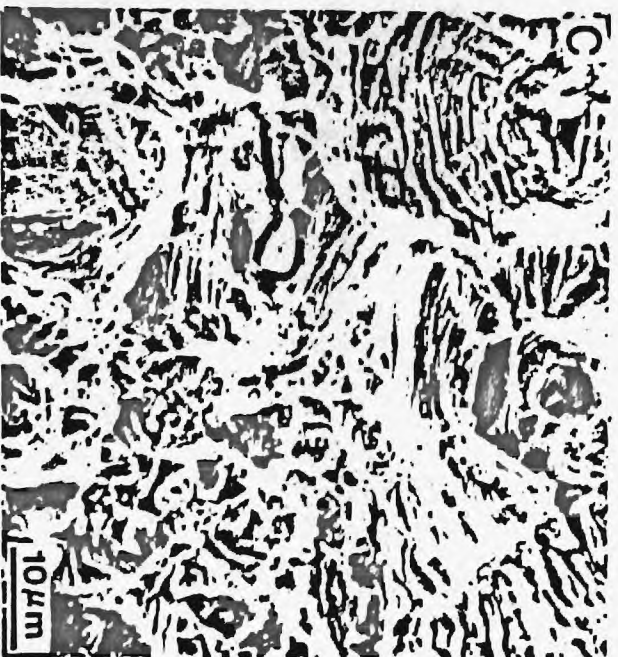
Figure 6-a. #3-80, 1000°F, 90 sec hold at max ΔK , ΔK_b = 65.6.
 6-b. #6-99, 1000°F, 5 min hold at max ΔK , ΔK_b = 58.0.
 6-c. #4-92, 1000°F, 5 min hold at max ΔK , ΔK_b = 57.5.

4. A longer hold time significantly increased the transition ΔK_b and Fig. 6 shows the fracture surface features.
